Manhole Inspection Summary

Manhole # S23II1032MH

Insp Date: **11/27/06 11:20 AM**

Location Address: **4207 EDGEHILL AVE**

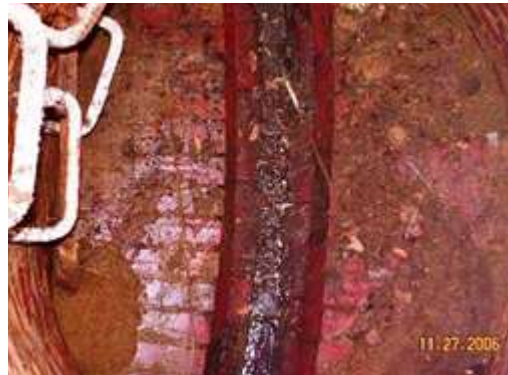
Top View

Evidence of surcharge - Bench debris.

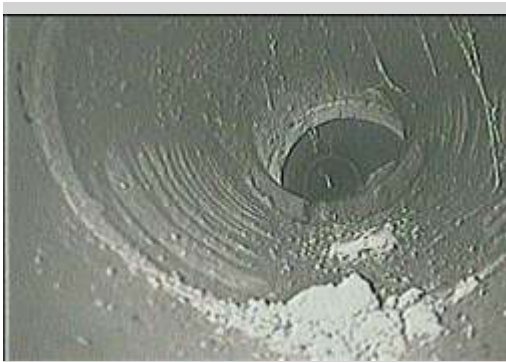
Inside the I7

Offset joint.

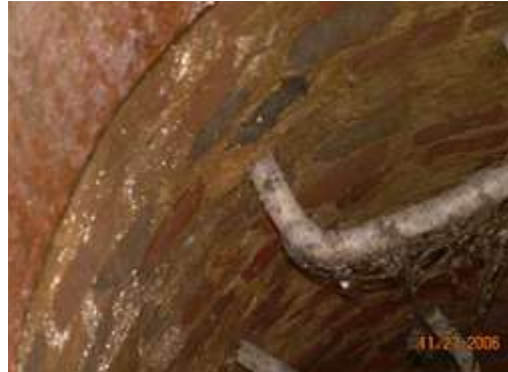
Defect

Infiltration: ☐ None ☒ **Joint** ☐ Cracks ☐ Mortar ☐ Roots ☐ Wall

Adjustment infiltration.

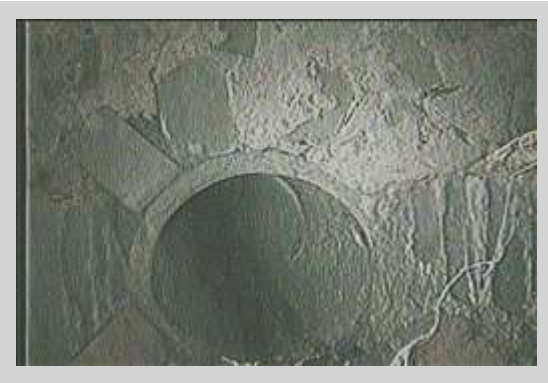
8 in. Circular Gravity Sewer Pipe Out @ 12 O'Clock

Channel root intrusion.

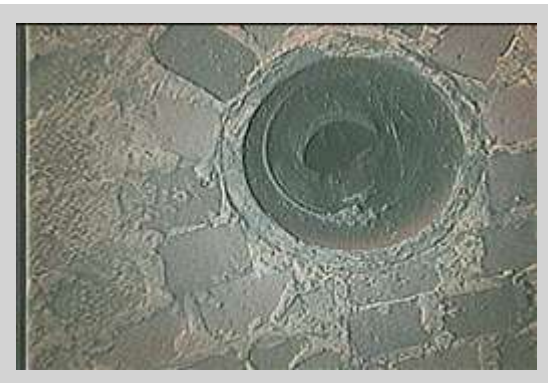
8 in. Circular Gravity Sewer Pipe In @ 7 O'Clock

Infiltration: **Evidence** Pipe Seal Cond: **Cracked**

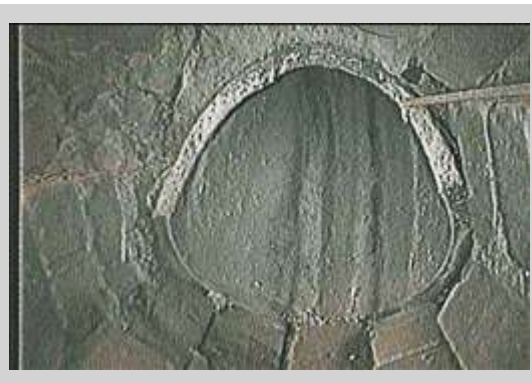
Drop In @ 7 O'Clock

Drop: **Outside** Rod and Bar

Drop Condition: **Open**
